## ENGINEERING BULLETIN

### Grain Cart Oiler Excess Oil Issue

RELEASE DATE: 9/17/2010

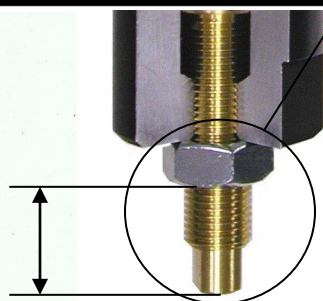
Turning Screw up  
gives less oil

5/8"

1. First, loosen the jam nut on the bottom of the oiler and
2. For Less Oil – Turn Screw up
3. For More Oil – Turn Screw down

Note: Do not exceed 15 turns in any one direction!
